PRIME CONSULTANT	
REVISIONS	
NO.	DATE
11/23/08	DRAFT
12/14/08	FIELD EDITS
12/17/08	FIELD EDITS
2/3/09	FIELD EDITS
2/11/09	FIELD EDITS
2/21/09	FINAL EDITS
2/25/09	FINAL EDITS
CLIENT	
STATE OF CALIFORNIA DEPARTMENT OF GENERAL SERVICES (DGS NO. 125828) (AGMT. NO. 3126150)	
PROJECT LOCATION	
BOARD OF EQUALIZATION BUILDING 450 N STREET SACRAMENTO, CA. 95814	
PROJECT	
STATE OF CALIFORNIA, DGS BOE ASSESSMENT (LCD NO. 2372-572)	
DESCRIPTION	
WATER DAMAGE SURVEY	
LOCATION	
MECHANICAL 12TH FLOOR	
SHT NO.	SHT NAME
13	A12

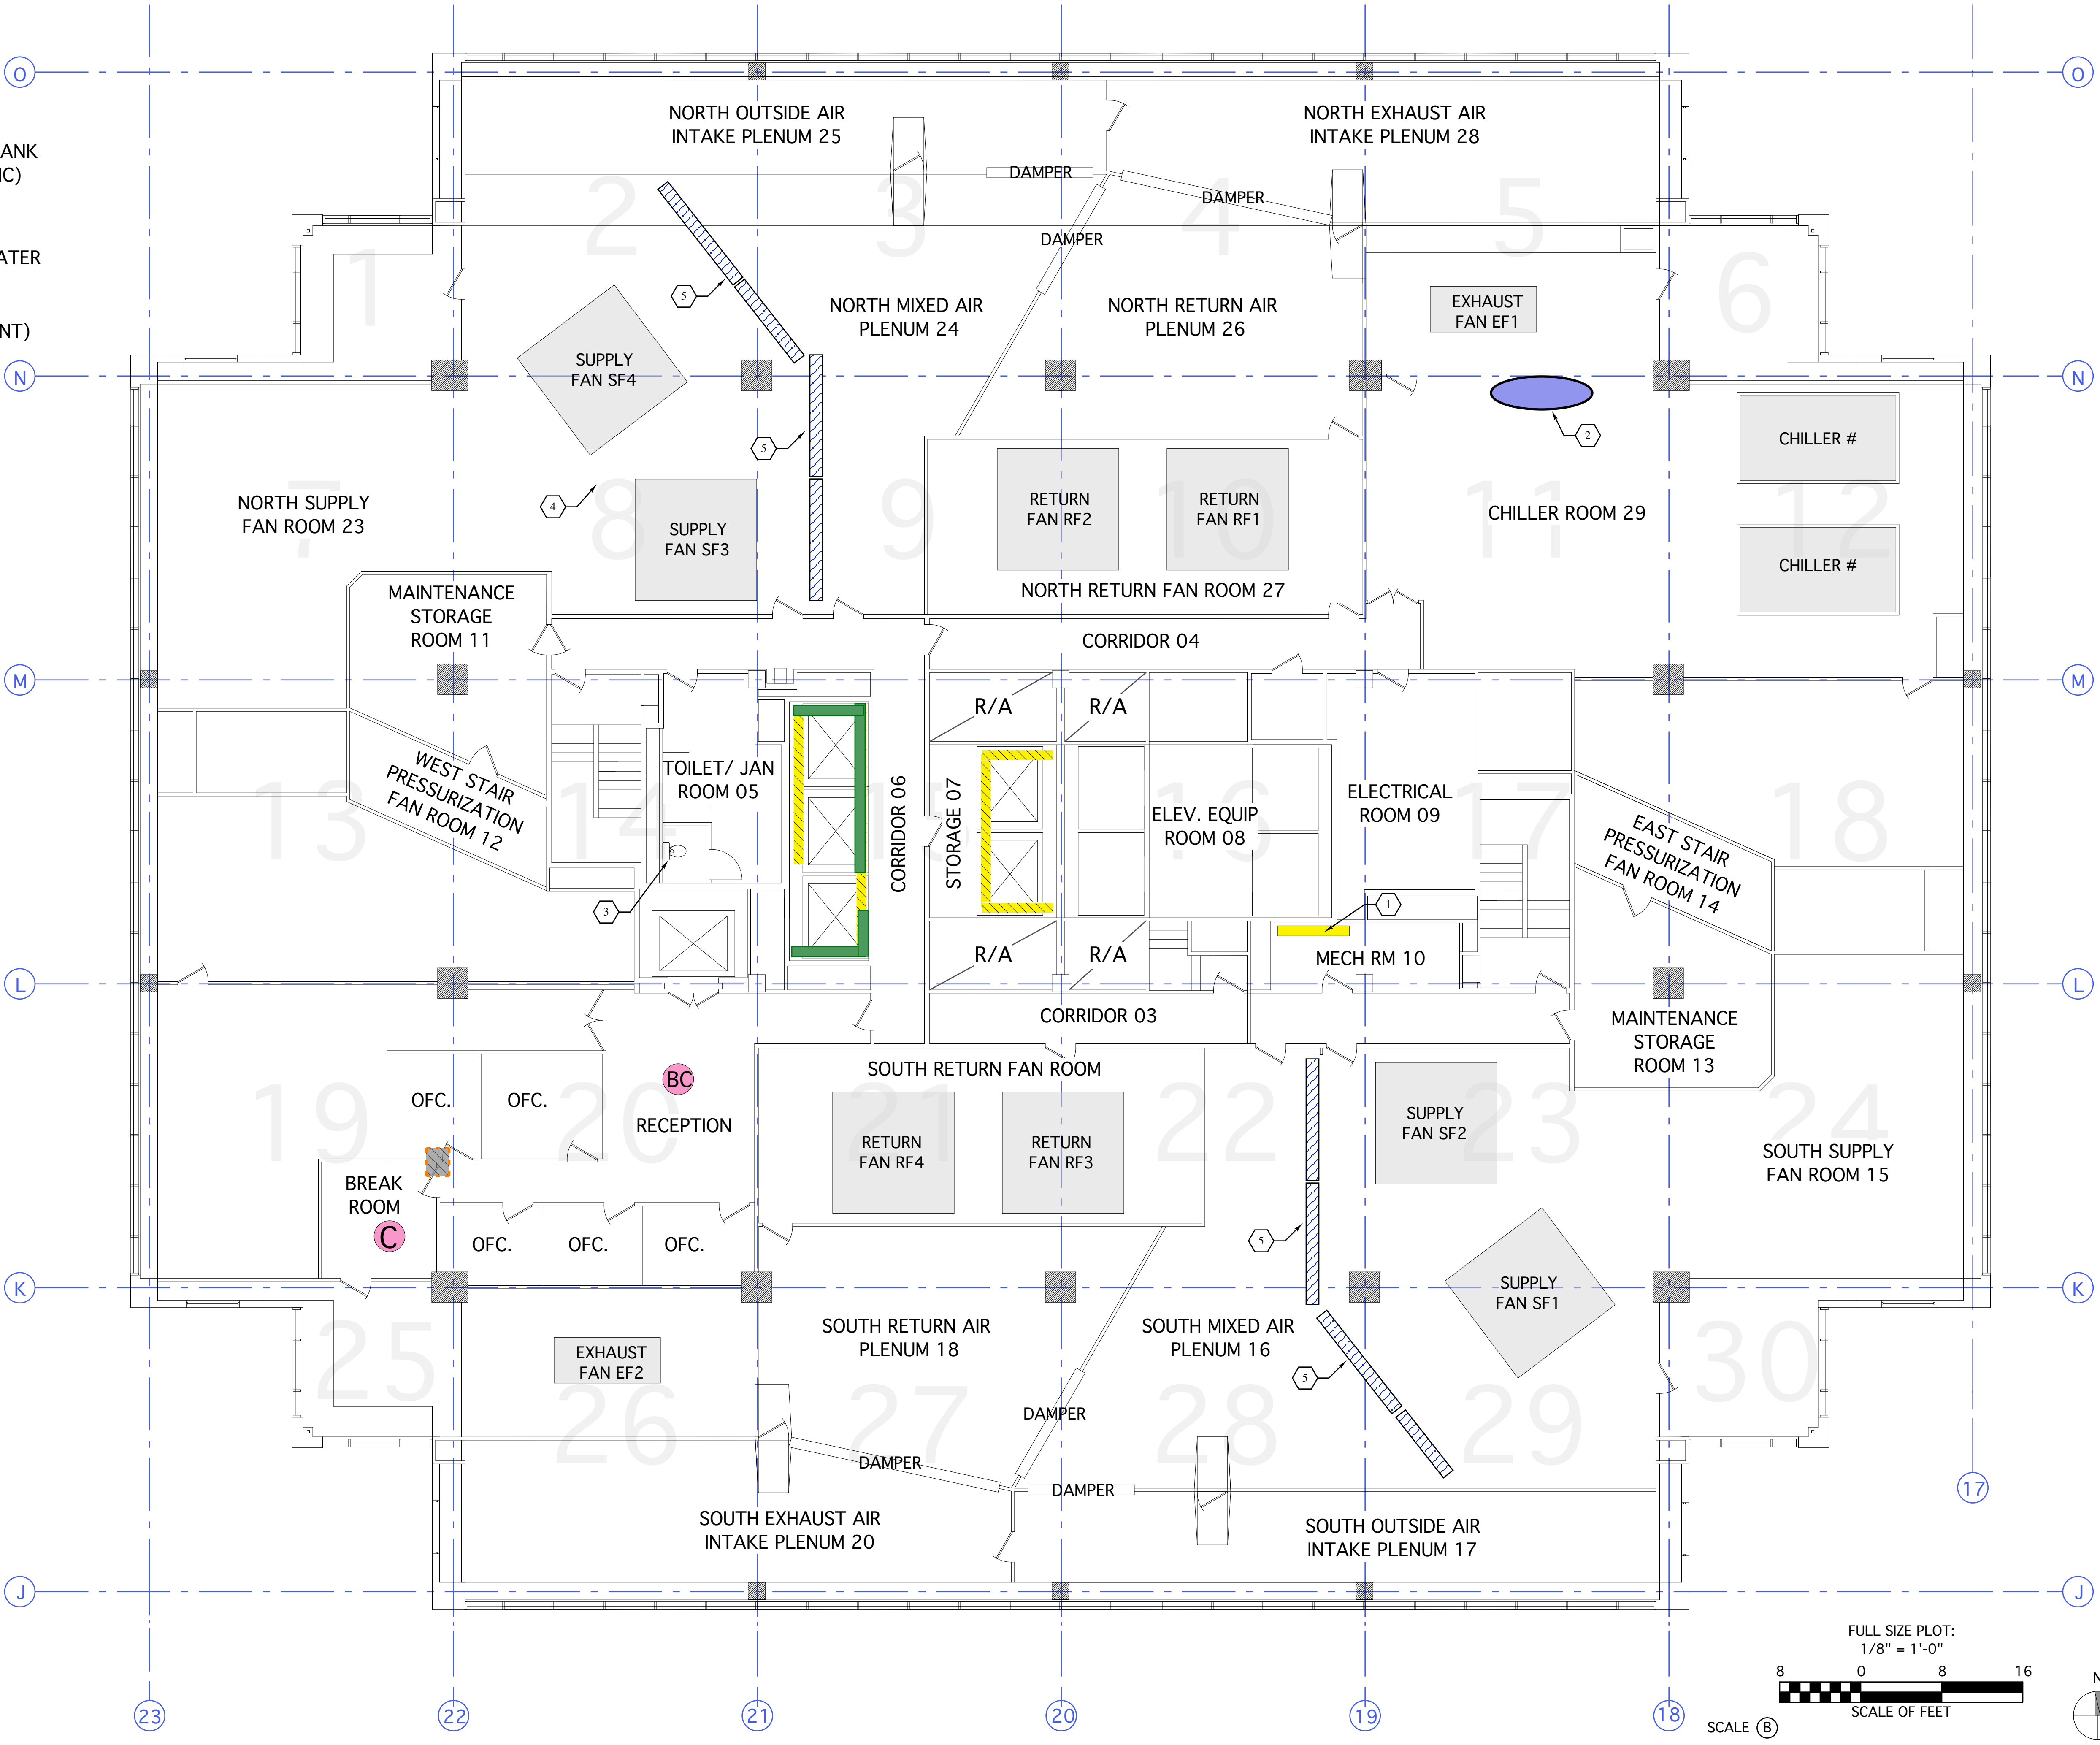
L/19 WS ON CONCRETE FLOOR (CURRENT)
- 2

N/18.5 FAILURE OF CHILLER TANK CHEMICAL MANIFOLD (HISTORIC)
- 3

FLOOR TILE DAMAGE FROM WATER BEHIND TOILET (CURRENT)
- 4

LOOSE ACOUSTIC C.T. (CURRENT)
- 5

CONDENSATE PANS RUSTING (CURRENT)
- 6
